# **Selected Images of the Effects of the October 15, 2006, Kīholo Bay-Māhukona, Hawai‘i, Earthquakes and Recovery Efforts**

Data Series 506

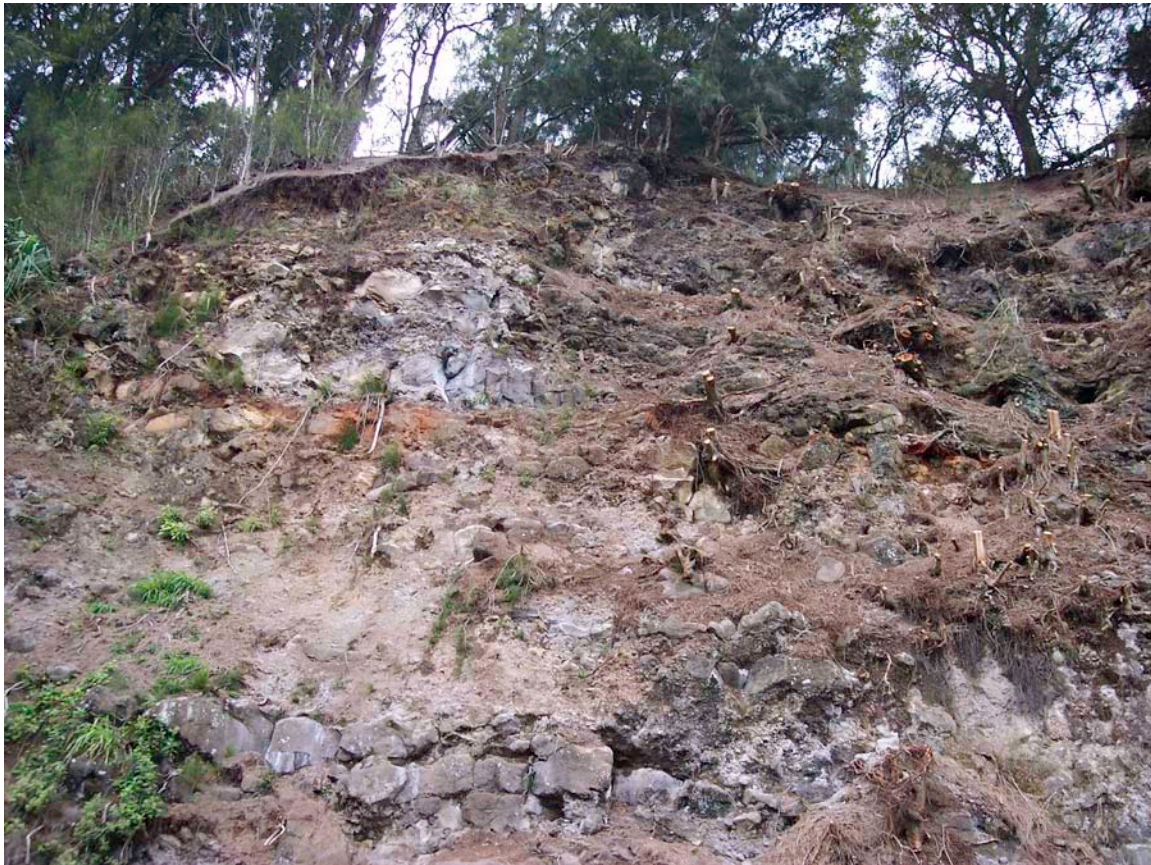
1.1. View of the cliff and stumps of freshly cut trees at the northern end of Laupāhoehoe Gulch, Highway 19 (view to the northwest). USGS photo by T.J. Takahashi, 3/3/2007 (tjt2931).

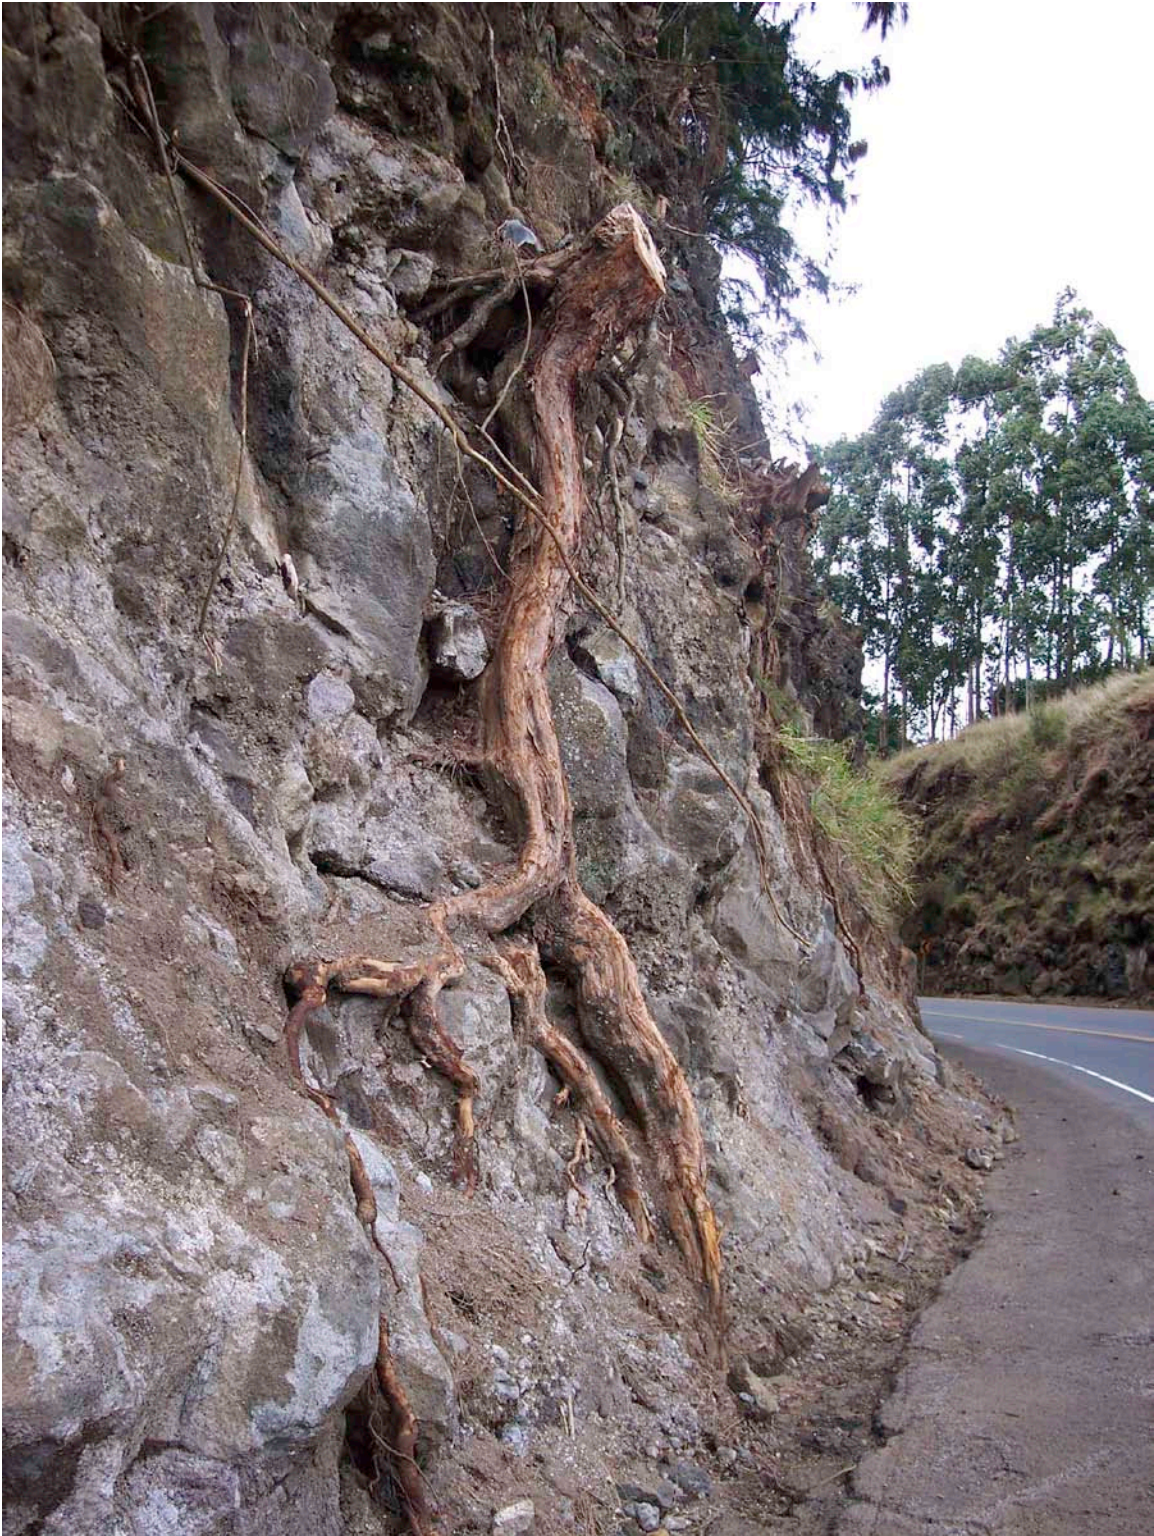
1.2. Close-up view of exposed roots of a tree, pruned to prevent rock falls at the northern end of Laupāhoehoe Gulch on Highway 19 (view to the north-northwest). USGS photo by T.J. Takahashi, 3/3/2007 (tjt2924).

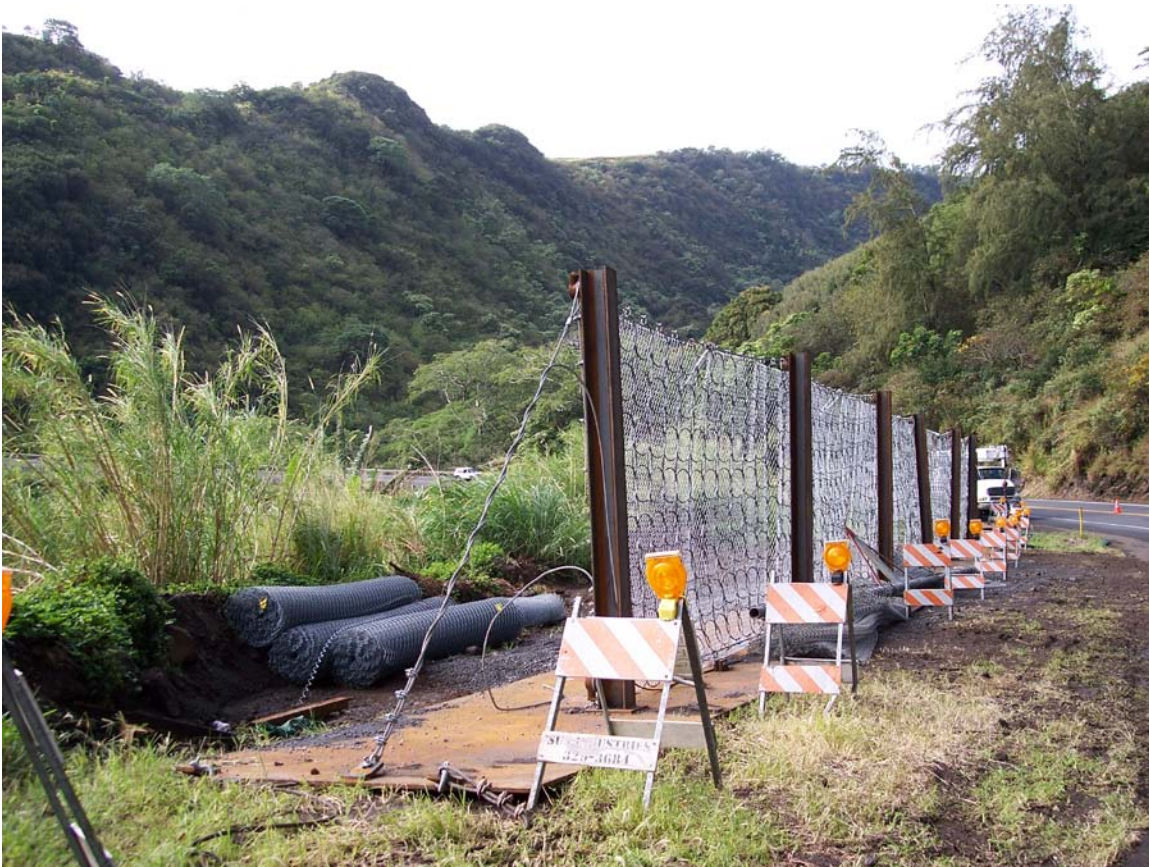
1.3. View of a rock-retaining fence, assembled on site to move into place at the southwest end of Laupāhoehoe Gulch, where rock and soil slides are common (view to the south-southwest). USGS photo by T.J. Takahashi, 2/9/2007 (tjt2422).

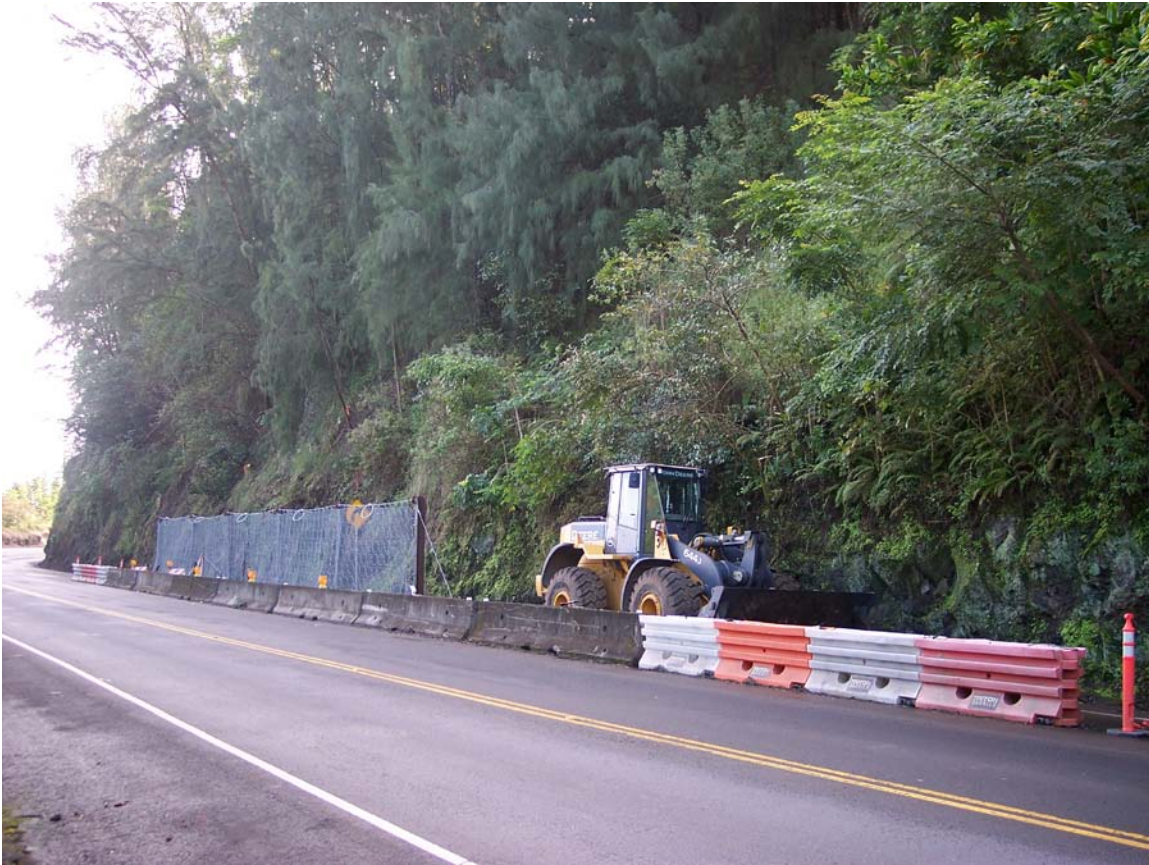
1.4. View of the rock-retaining fence, installed to capture rocks and debris at the northeast end of Laupāhoehoe Gulch, Highway 19 (view to the northeast). USGS photo by T.J. Takahashi, 3/3/2007 (tjt2791).

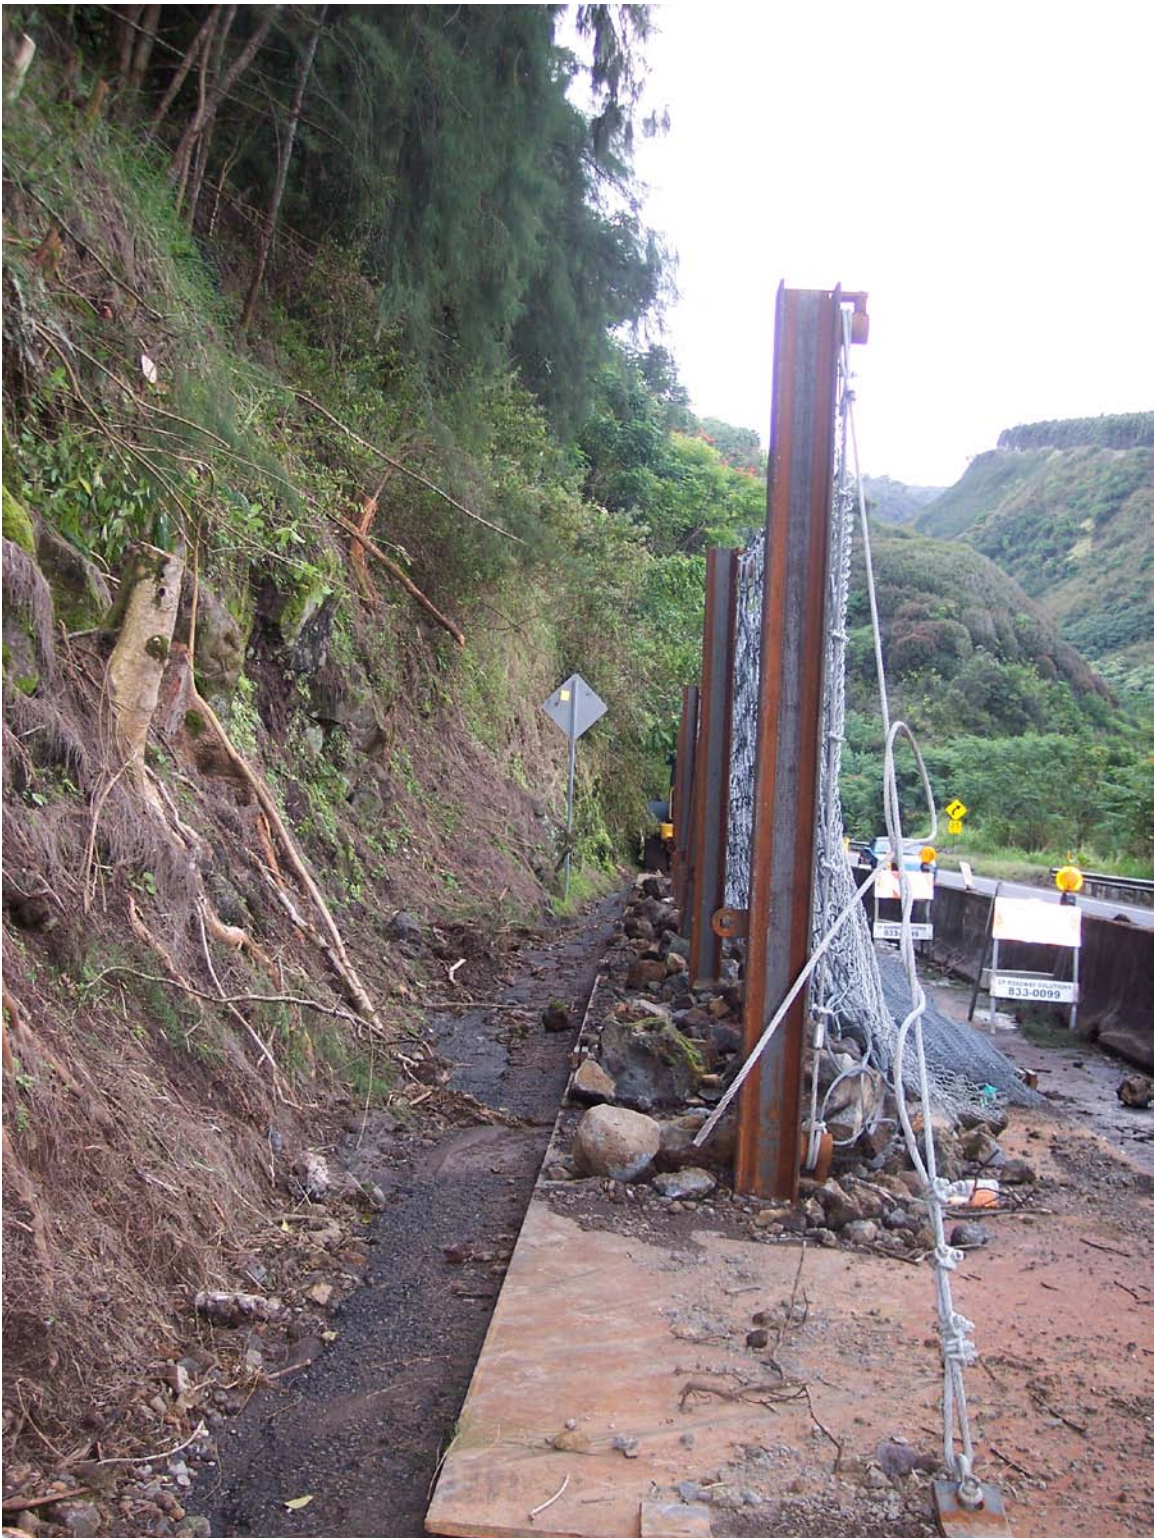
1.5. Profile view of the rock-retaining fence, showing rock debris caught behind the fence at the northeast end of Laupāhoehoe Gulch (view to the south-southwest). USGS photo by T.J. Takahashi, 3/3/2007 (tjt2937).

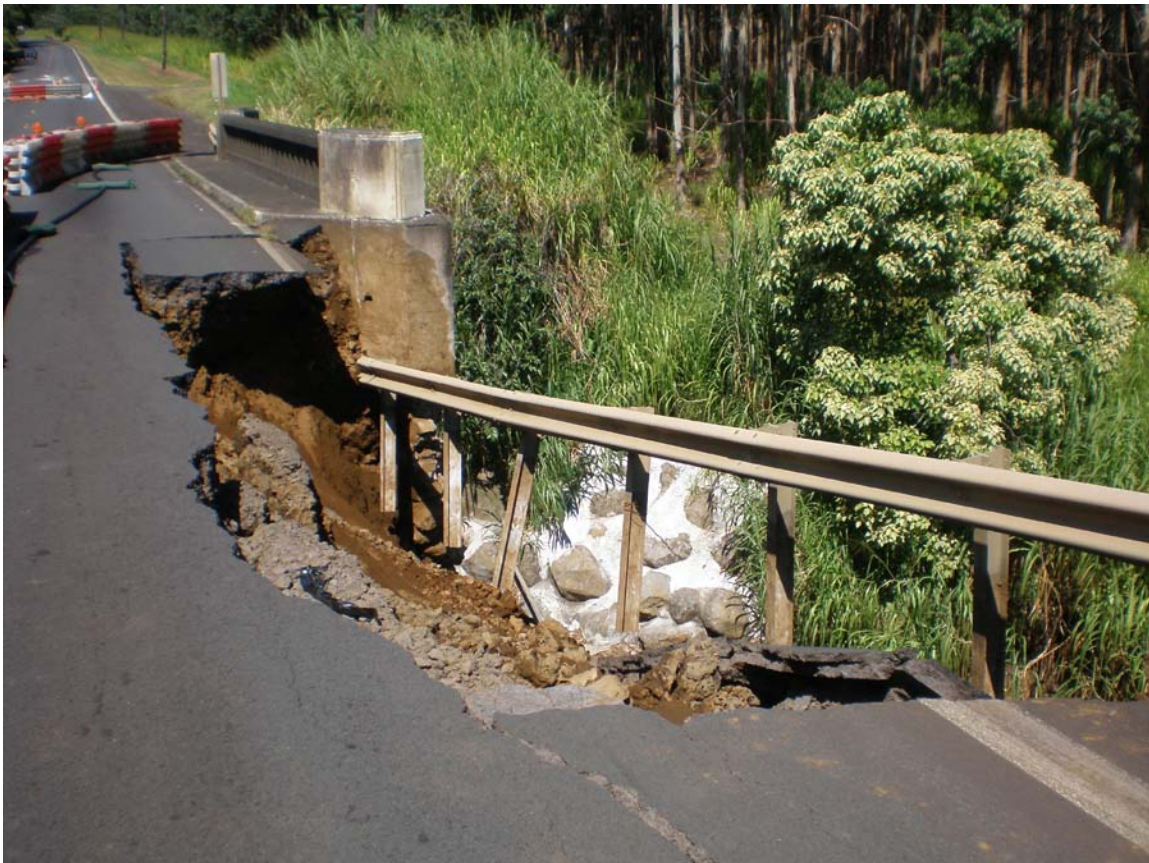
The asphalt pavement of Highway 19 buckled and collapsed when the shoulder at the southeastern approach to Kawāili Bridge in Pa‘auilo gave way from the effects of the earthquake. The northbound lane was closed quickly, and the highway was turned temporarily into a one-lane road. A portable signal light was installed, and a metal bypass bridge was constructed to reroute traffic. A network of road cracks southeast of Kawāili Bridge points to unseen damage underlying the roadway. As of this writing, Kawāili Bridge remains unrepaired and unutilized.

2.1. View of the collapsed section of Highway 19, southeast of Kawāili Bridge, between Kūka‘iau and Pa‘auilo (view to the northwest). USGS photo by C. Francos, 10/17/2006 (cf016).

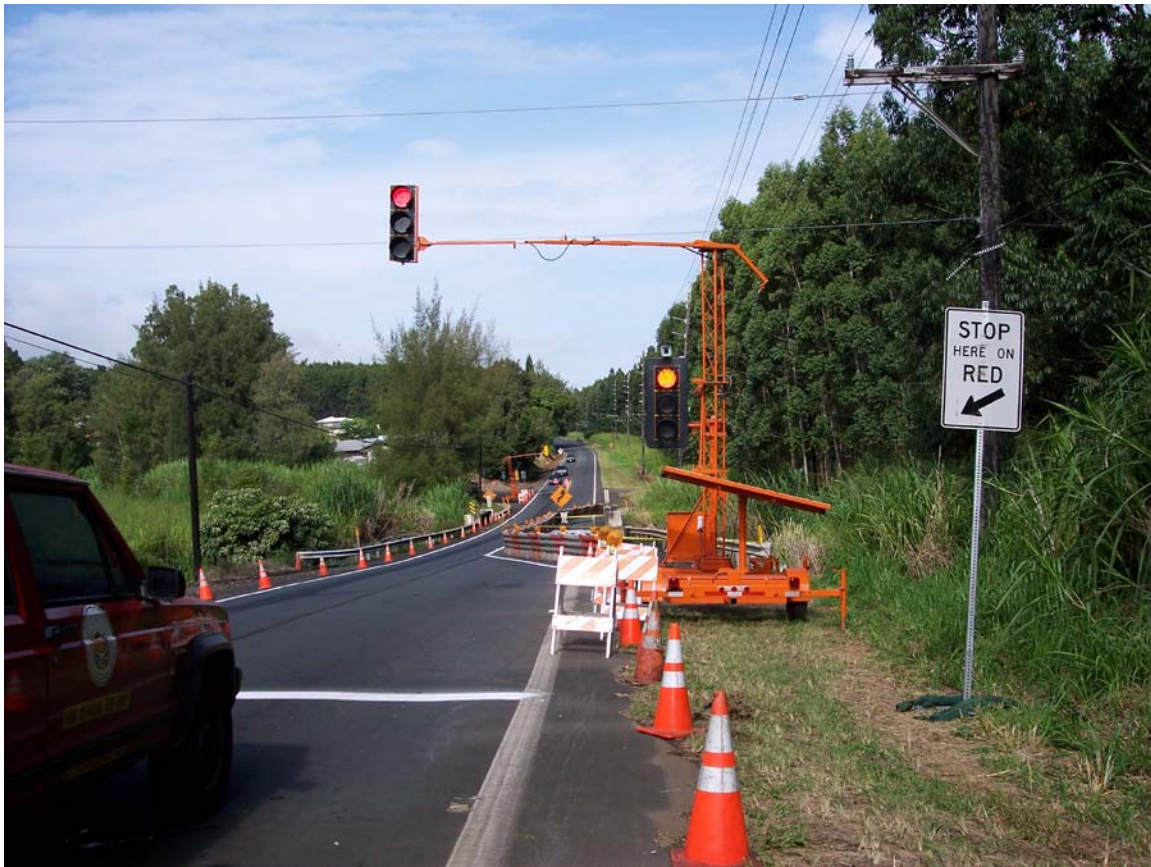
2.3. View of temporary traffic lights that regulate the single lane of traffic past the damaged road (view to the northwest on Highway 19). USGS photo by T.J. Takahashi, 10/20/2006 (tjt1141).

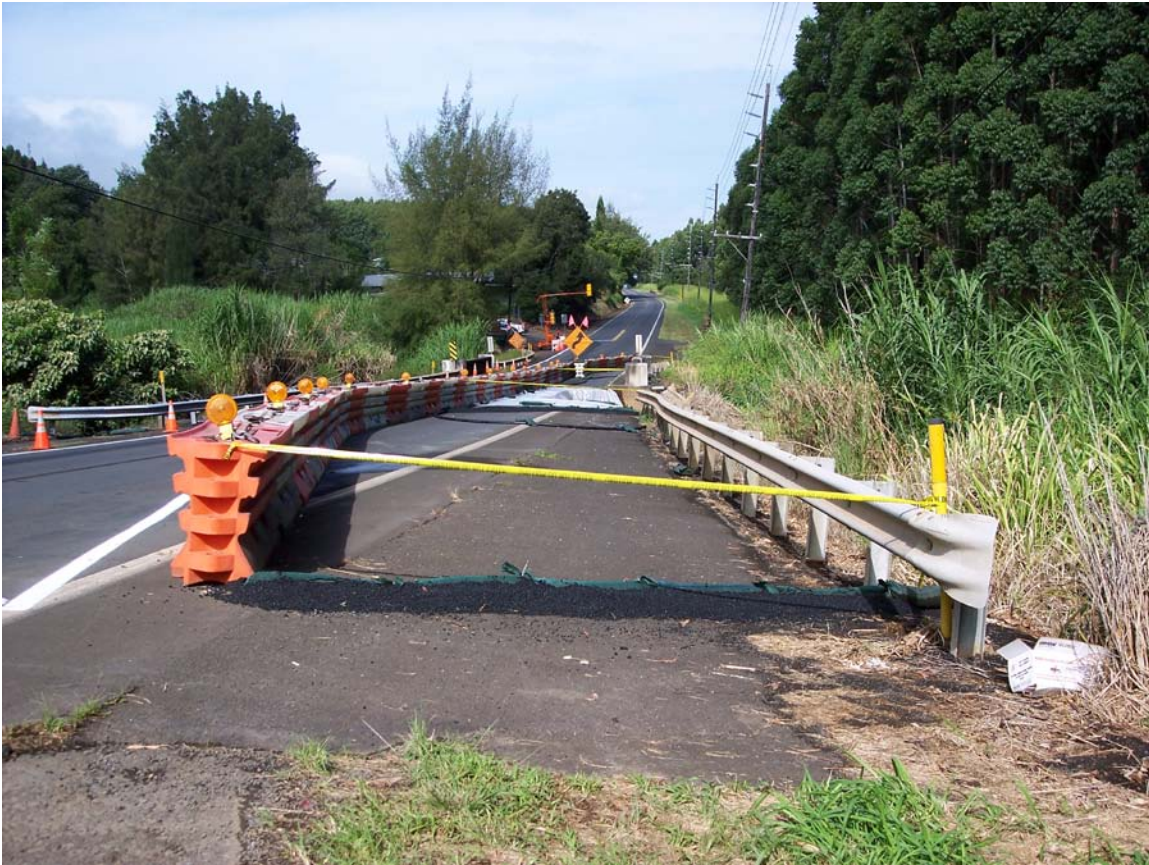
2.4. View of Driscoll lines (black plastic hoses)—anchored by green sandbags within the cordoned-off area—provide temporary delivery of potable water to nearby residents and animals after the water main ruptured ((M. Asato, oral commun., 11/17/09); view to the northwest on Highway 19). USGS photo by T.J. Takahashi, 10/20/2006 (tjt1143).

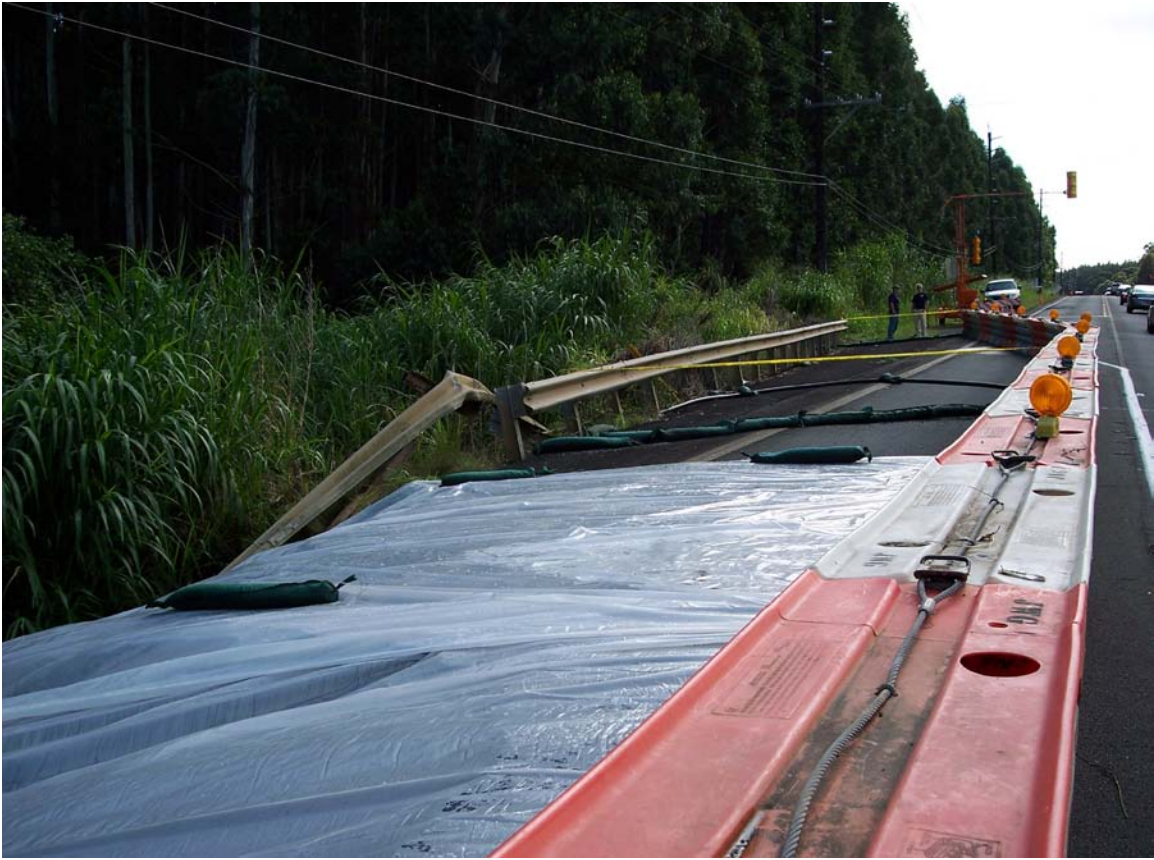
2.5. Close-up view of the collapsed guardrail on the north side of the highway. White plastic sheets, held in place by green sandbags, cover the collapsed roadway and slope to prevent further erosion from rainfall (view to the southeast on Highway 19). USGS photo by T.J. Takahashi, 10/20/2006 (tjt1146).

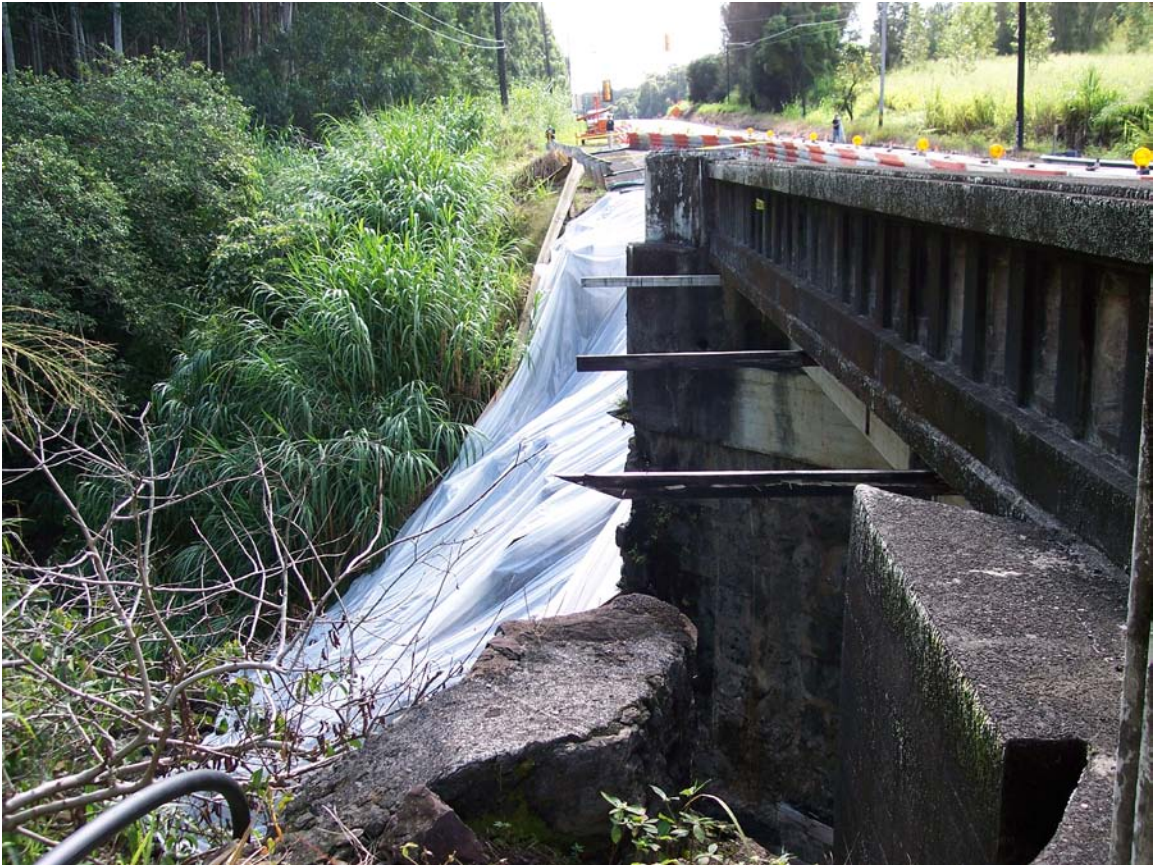
2.6. View of wooden struts supporting the concrete slabs of the bridge, exposed after the slabs broke off and fell into the gulch below. At the southeastern end of the bridge, white plastic sheets cover the collapsed slope to prevent erosion (view to the southeast). USGS photo by T.J. Takahashi, 10/20/2006 (tjt1148).

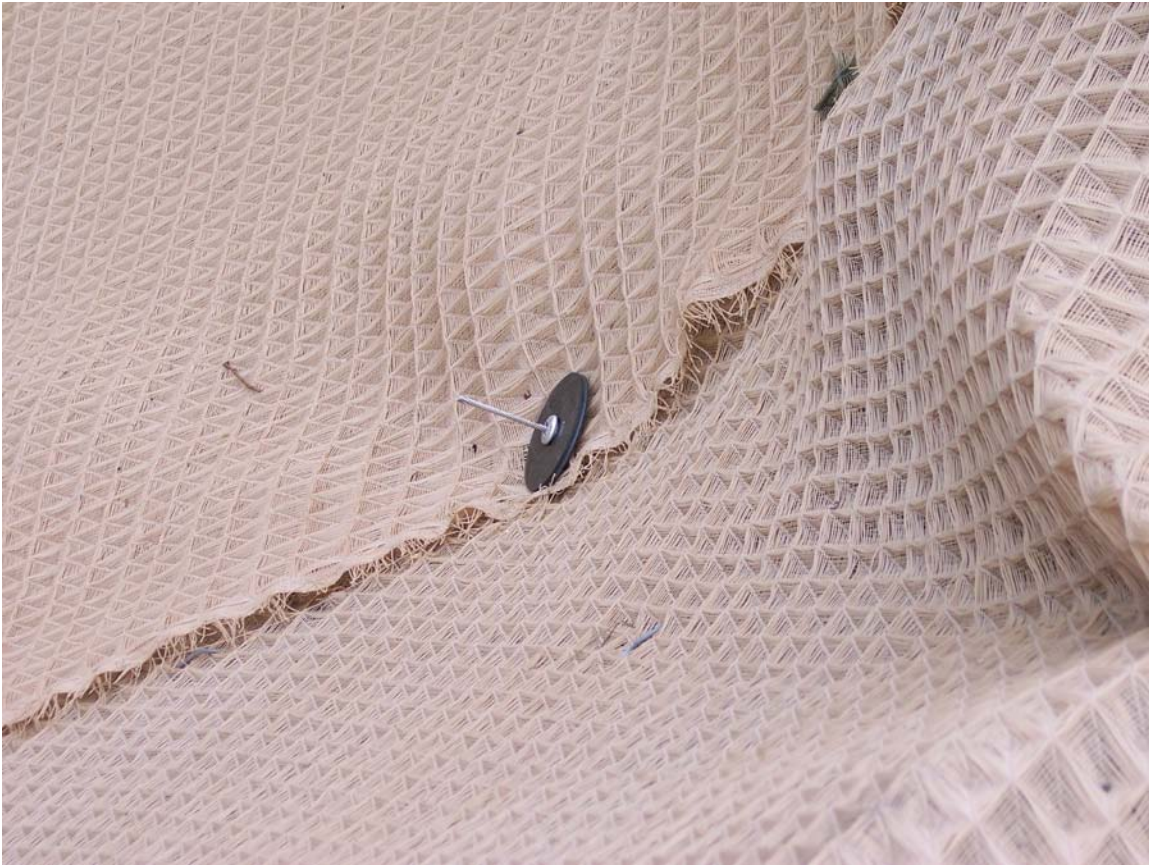
2.9. Close-up view of the weather-resistant nylon-polymer fabric and 0.3-m-long (1-ft) stainless-steel pin used to fasten the cloth securely into the ground. USGS photo by T.J. Takahashi, 2/9/2007 (tjt2472).

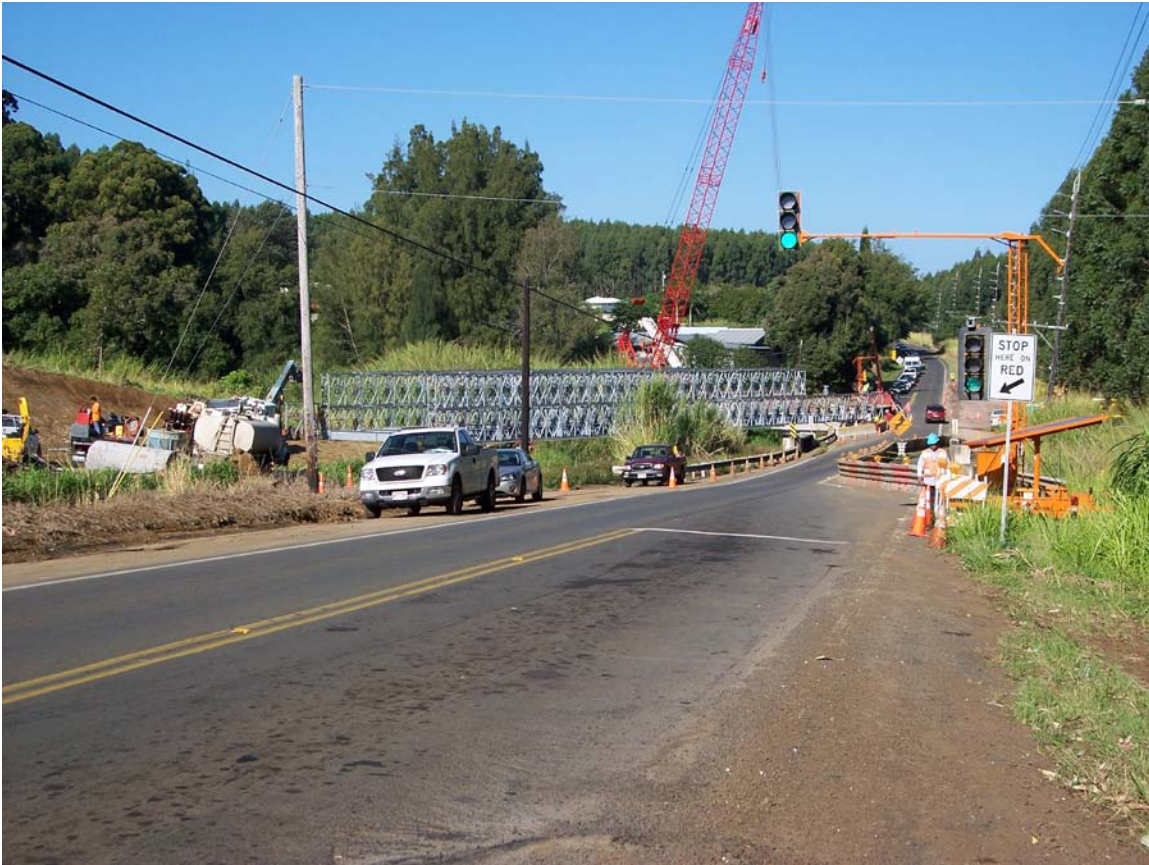
2.10. View of the bridge for the bypass road (under construction), which provides a detour from the damaged section of the highway (view to the northwest on Highway 19). USGS photo by T.J. Takahashi, 1/20/2007 (tjt2322).

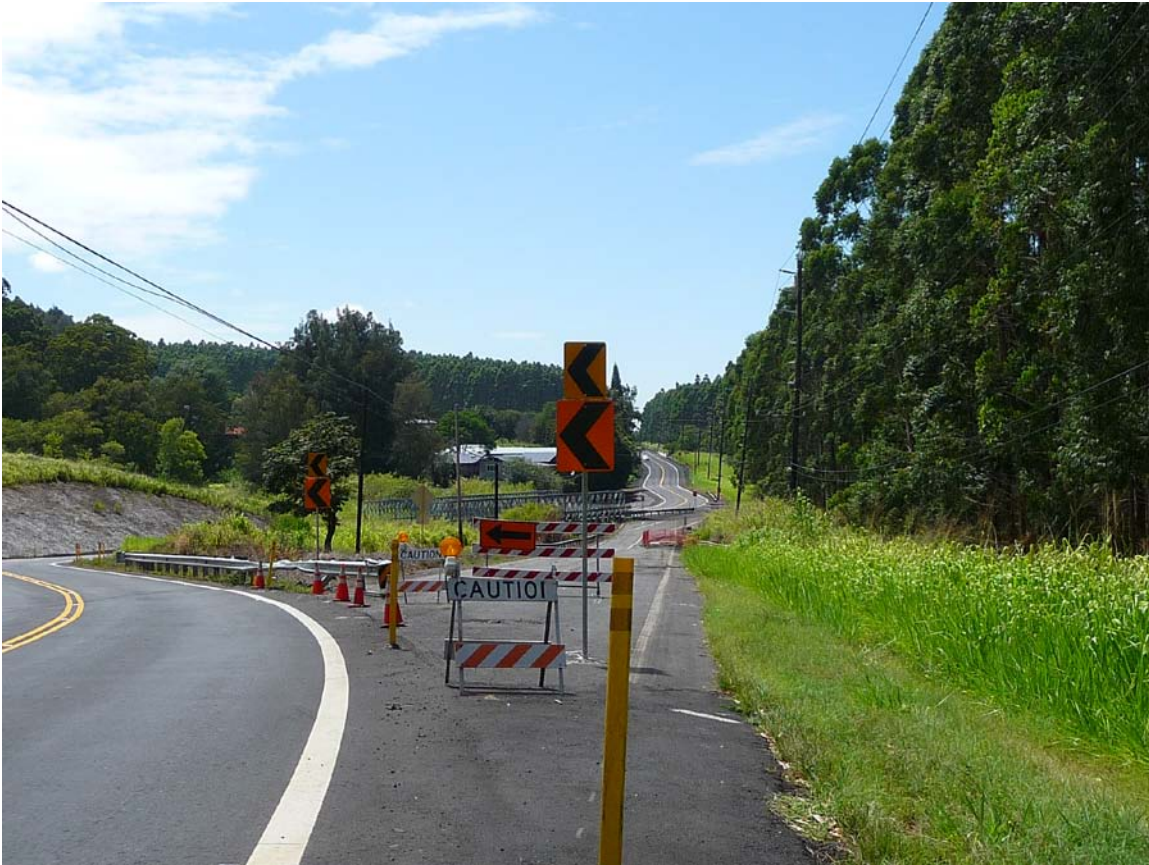
2.12. View of the relative location of the bypass from the damaged Kawāili Bridge road (view to the northwest on Highway 19). USGS photo by N.A. Ikeda, 7/26/2008 (nai960).

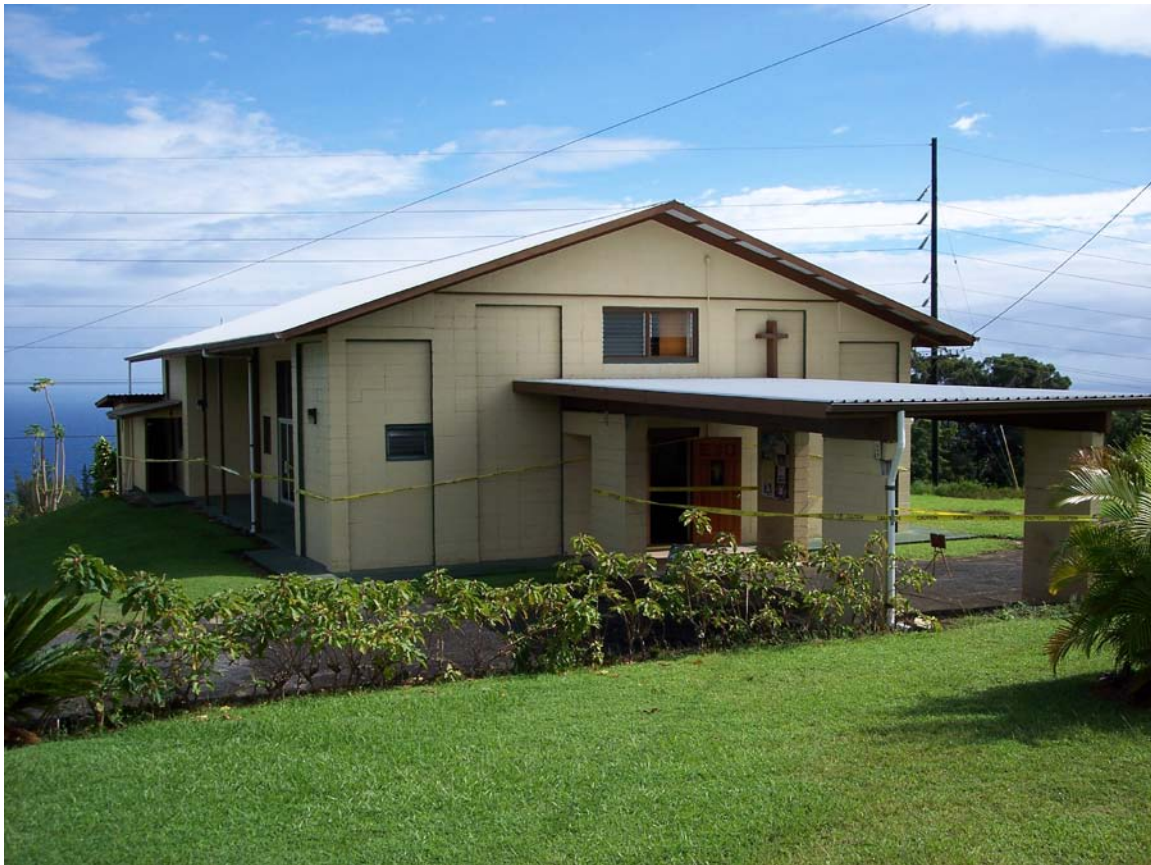
St. Joseph Catholic Church in Pa‘aulo, built in 1957, was constructed primarily of wood, cement, and concrete blocks. The church suffered severe structural damage from the effects of the earthquake, including cracks in exterior and interior walls, dislodged blocks, and offset roof-support pillars. Environmental damage included ground cracks and slumping behind the church. The church was closed, and the Diocese in Honolulu made a subsequent decision not to restore it. Parishioners were invited to attend services at Our Lady of Lourdes Church in Honoka‘a, 11.3 km (7 mi) away. After a final prayer service and potluck, St. Joseph Catholic Church was demolished, nearly two years after the earthquake occurred. The parish hall (the church’s other building), sustained minor damage, and the posts, offset from their piers, were restored to their original positions. The hall is currently utilized for religious education classes and social gatherings (Weaver, 2008).

3.1. *Overview image:* St. Joseph Catholic Church, yellow-tagged (allowing restricted occupancy and use) and closed due to structural damage (view to the northeast). USGS photo by T.J. Takahashi, 10/20/2006 (tjt1150).

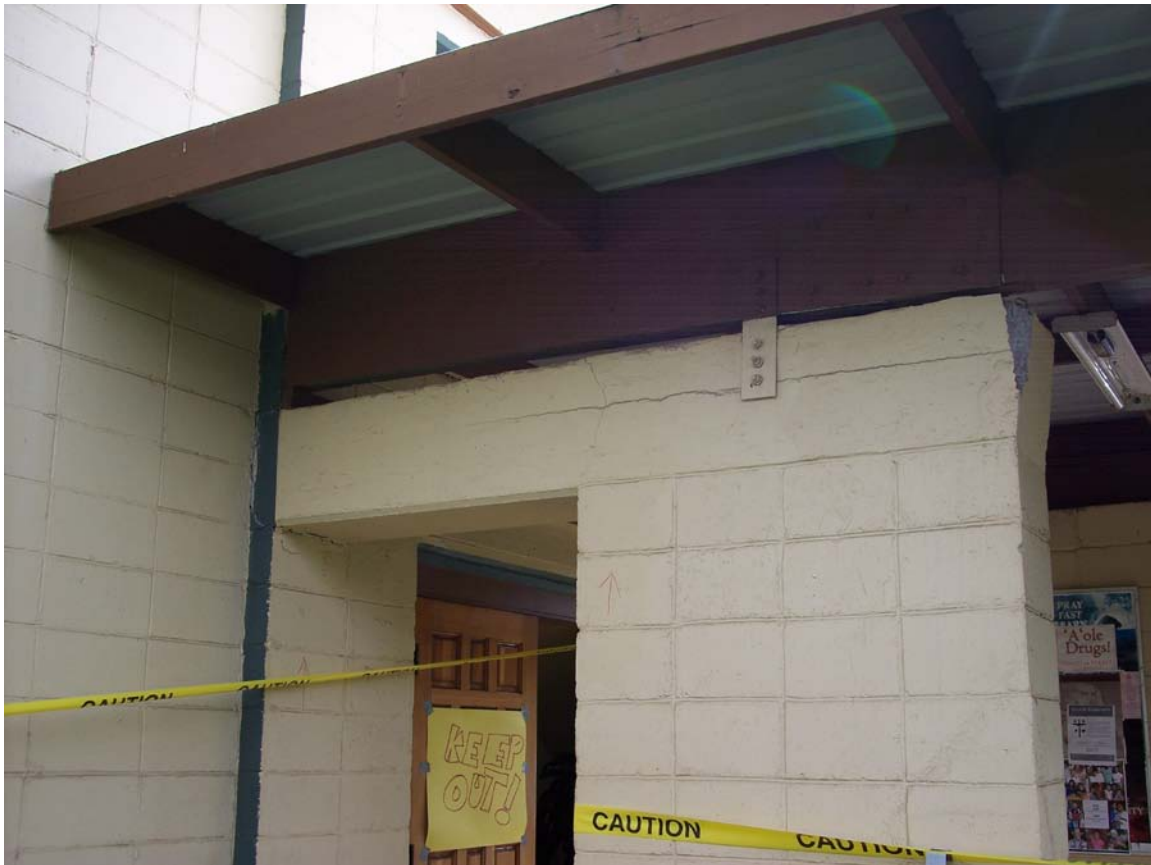
3.3. Close-up view of the separation of the horizontal concrete blocks from the brown, wooden beam above. The red arrow points to cracking along grout lines between concrete blocks in the covered entrance (view to the northeast). USGS photo by T.J. Takahashi, 10/20/2006 (tjt1155).

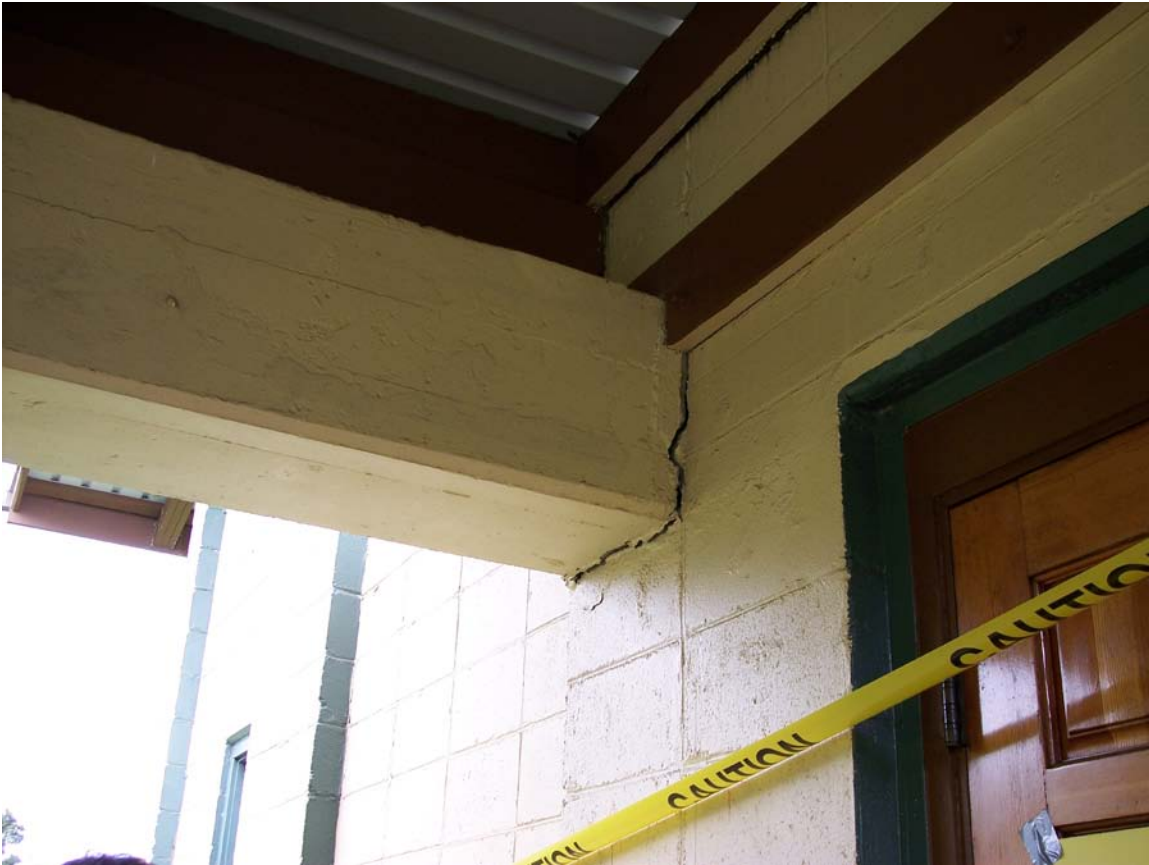
3.4. Close-up view of the separation of the concrete beam of the covered walkway from the reinforced hollow tile wall at the front entrance (view to the northwest). USGS photo by T.J. Takahashi, 10/20/2006 (tjt1210).

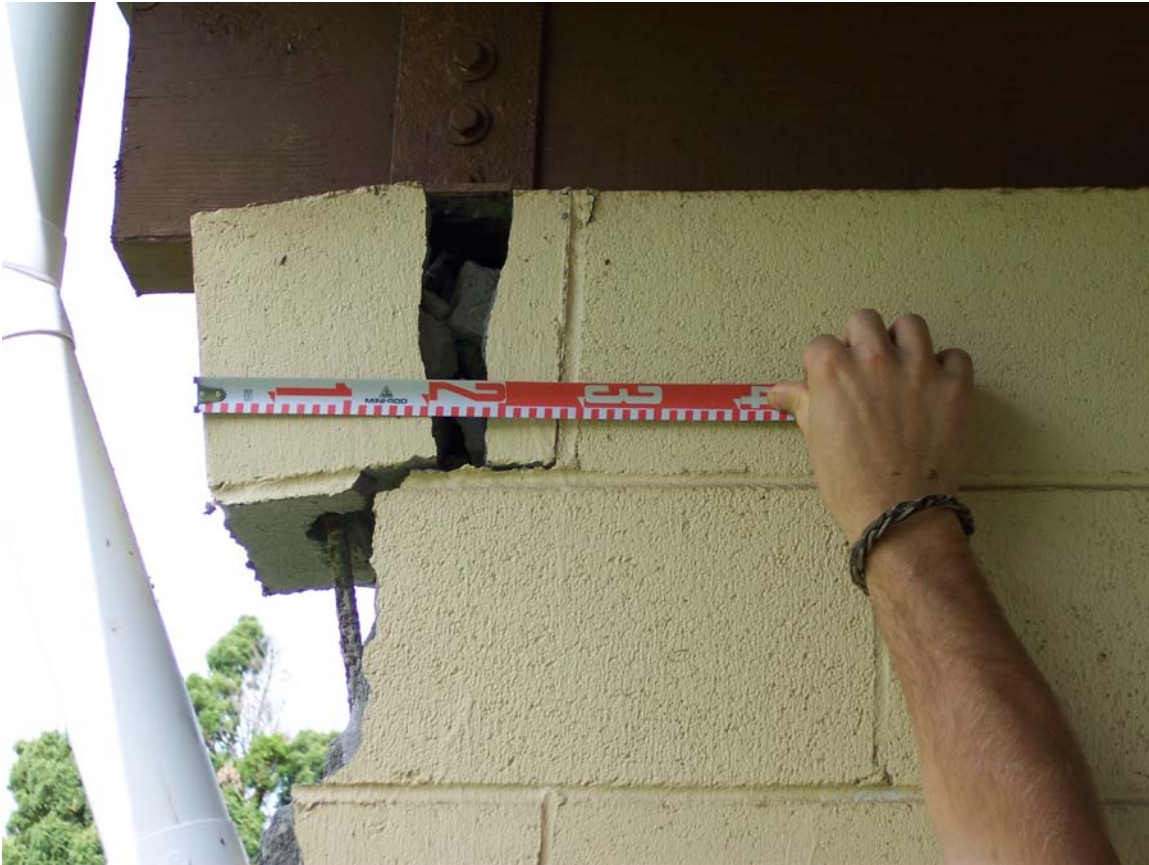
3.7. View of tape showing approximately 5 cm (1.9 in.) of offset in the displaced hollow tile block at the top of the driveway pillar (seen in photos 3.5 (tjt1218) and 3.6 (tjt1221); view to the west-northwest). USGS photo by T.J. Takahashi, 10/20/2006 (tjt1231).

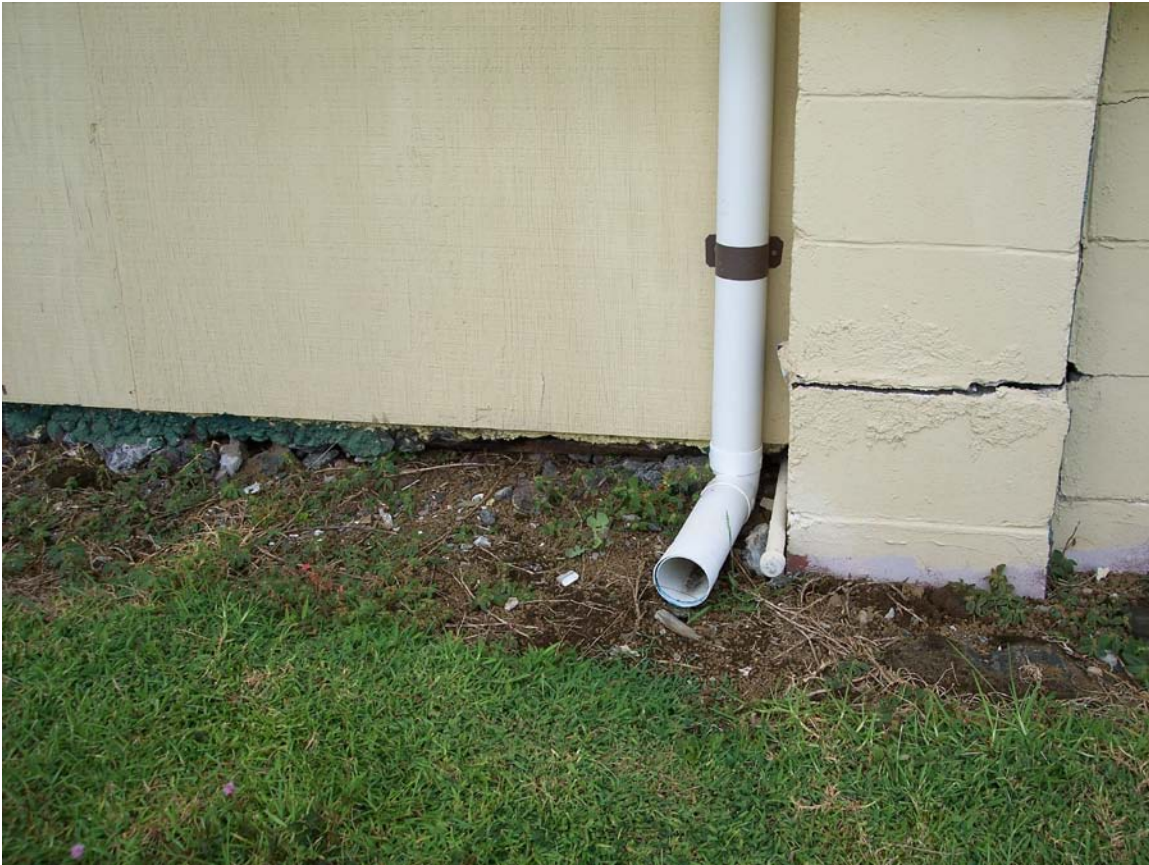
3.9. Close-up view of ground slumping and of cracks in the mortar (see photo 3.8 (tjt1179)) between reinforced hollow tile blocks (view to the west-northwest). USGS photo by T.J. Takahashi, 10/20/2006 (tjt1183).

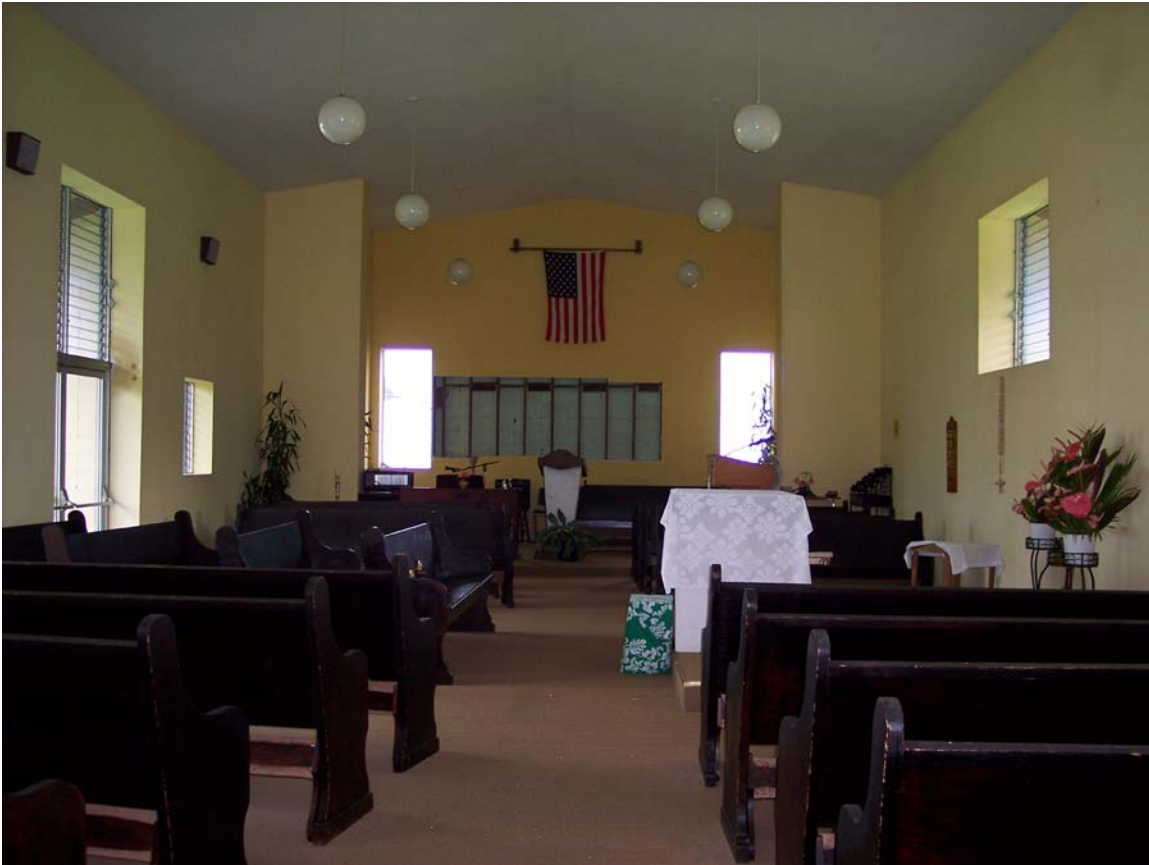
3.10. View of the interior, the least damaged part of the church, with the exception of fallen drywall in the choir section, just under the American flag (view to the northeast). USGS photo by T.J. Takahashi, 10/20/2006 (tjt1215).

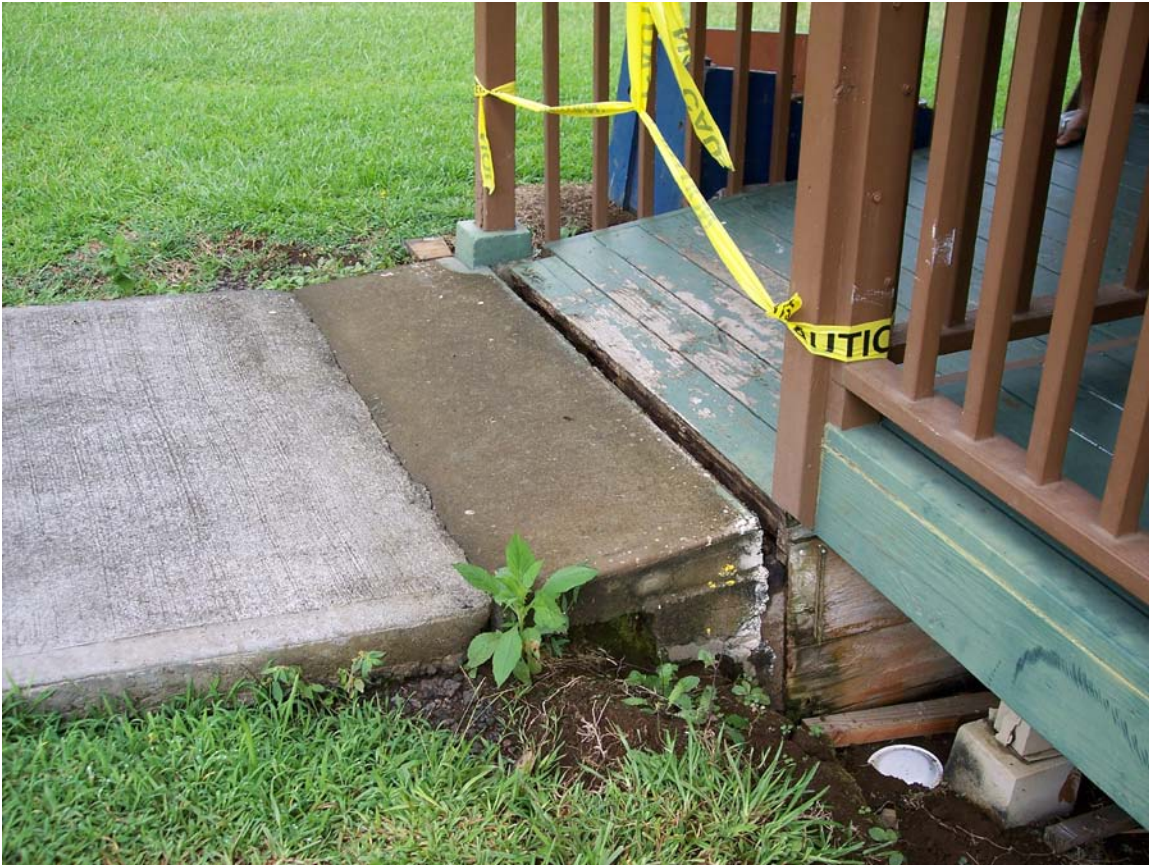
3.11. View of the separation between the concrete walkway and the entrance to the lānai (veranda) around the parish hall (view to the north). USGS photo by T.J. Takahashi, 10/20/2006 (tjt1196).
